**A Compendium of Bonded Repairs
Applied to the PC9/A Full Scale
Fatigue Test Article During Testing**

Richard Bartholomeusz,
Rowan Geddes and Peter Chalkley

DSTO-TN-0324

**Airframes and Engines Division
Aeronautical and Maritime Research Laboratory**

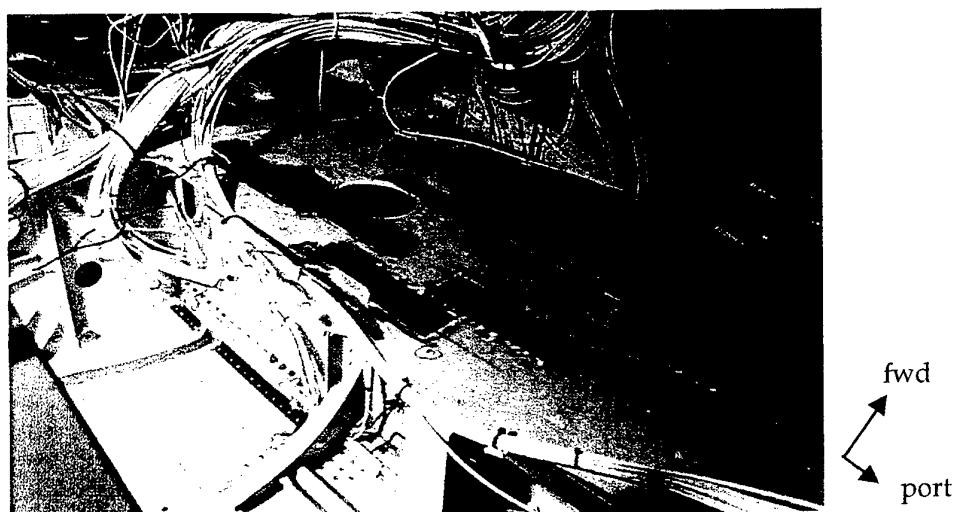
Figure 2. *Photograph of the centre section of the lower wing-skin showing repairs.*

Cracking during testing occurred in the wing centre-section on the lower wing-skin and in the fuselage skin near the tail fin. Figure 2 shows a photograph of the lower wing-skin with all the repairs applied.

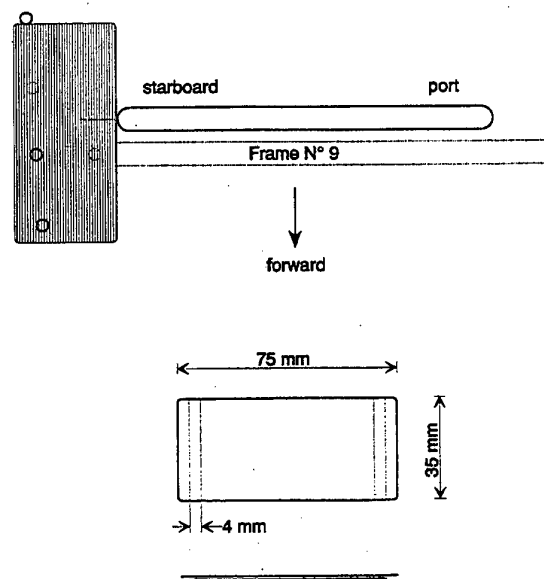
Figure 4. Repair to the slotted hole in the top skin at the forward fin attachment

An adhesively bonded boron/epoxy patch was applied to a crack in the top skin emanating from a slotted hole at the forward fin attachment at 6,000 SFH.

The patch was designed simply on the basis of stiffness matching with the aluminium skin. A three-ply unidirectional boron/epoxy layup was chosen. The thickness of the patch was approximately one third that of the skin as unidirectional boron/epoxy has a modulus approximately three times that of aluminium. The ends of the patches were stepped, at 4 mm per step, to reduce stresses at the patch ends. The patch configuration is shown in Figure 4.

The boron/epoxy patch was bonded to the aluminium skin using the two-part structural acrylic – Click Bond 200-40. This adhesive cures at room temperature and attains 90% of full strength within one hour. No details of the pressurisation method were recorded.

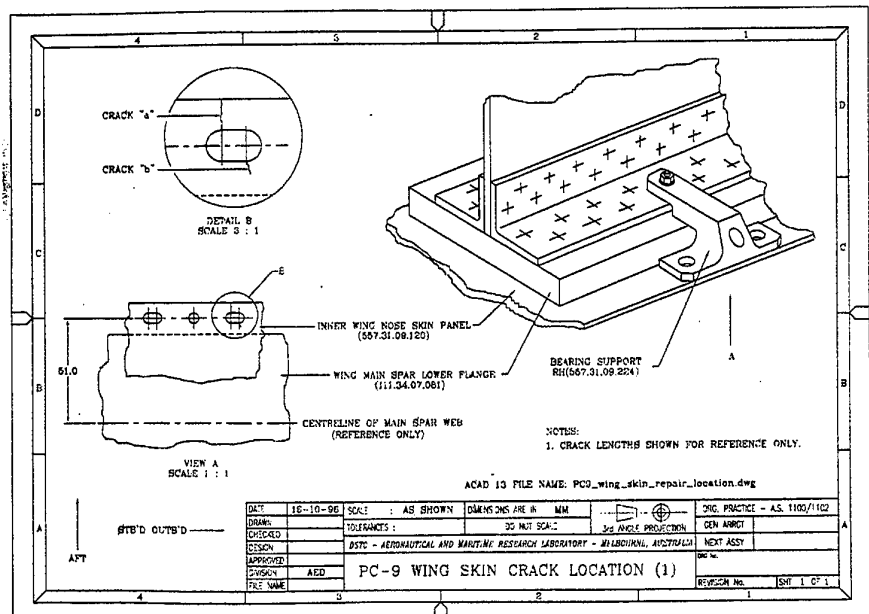
Figure 5. Starboard Wing Uplock Mechanism- Crack Location.

Figure 5 shows the crack location on the starboard wing as at approx. 10,000 SFH.

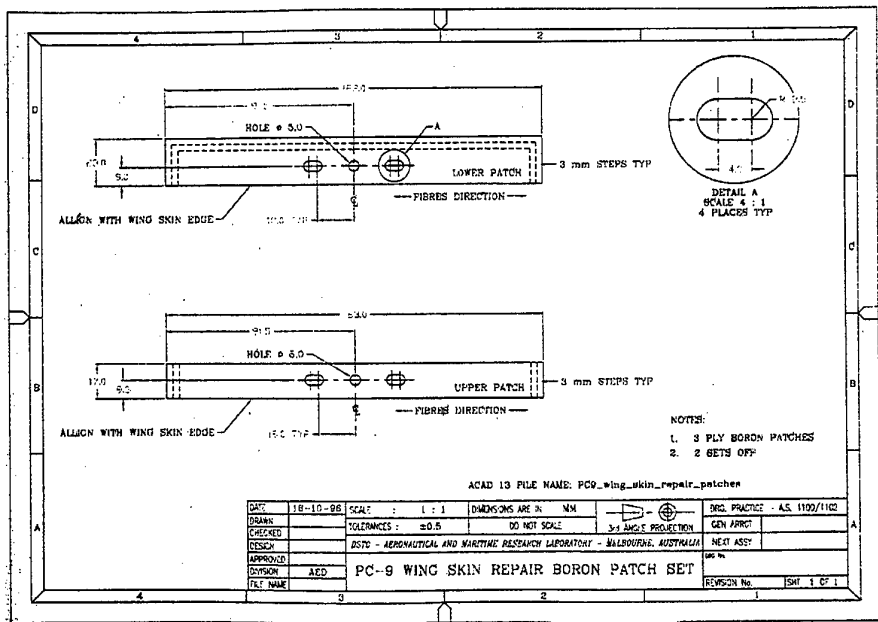
Figure 6. Starboard Wing Uplock Mechanism- Patches.

No crack growth occurred in the starboard lower skin after repair. The patches, which were applied at 10,000 SFH, were removed at 34,000 SFH to allow a re-profiling modification to the region. The port side patches were fitted at about 15,500 SFH. By 17,000 SFH the crack had grown beyond one edge of the external patch. It is thought that the use of the structural acrylic paste resulted in a very thick adhesive bondline which meant that the effectiveness of the patches in reducing crack opening would have been reduced. The patch applied subsequently to the port side used the structural epoxy adhesive FM73. A thicker patch was also employed (a single ten ply patch rather than two three ply patches).

Figure 6 shows a drawing of the patches which were bonded to the aircraft using Click Bond 200.

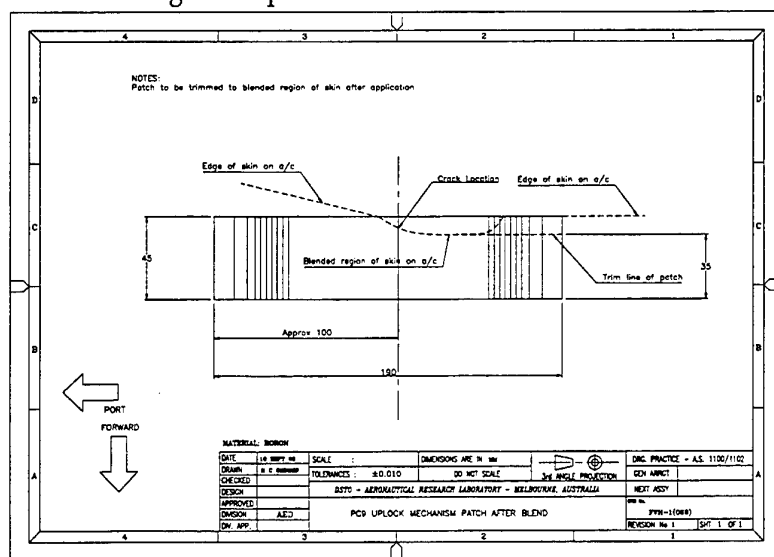
Figure 7. Drawing of the port uplock mechanism patch applied at 38,000 SFH.

A thicker ten-ply patch was bonded using FM73 to the blended-skin of the port uplock mechanism at 38,000 SFH following re-cracking of this part. At 38,000 SFH the underlying spar had satisfied the requirement of undergoing three lifetimes of loading and so the restriction on patch thickness due to lifing considerations was removed. Eddy-current inspection of the crack showed that this patch stopped crack growth. Figure 7 shows a drawing of the patch.

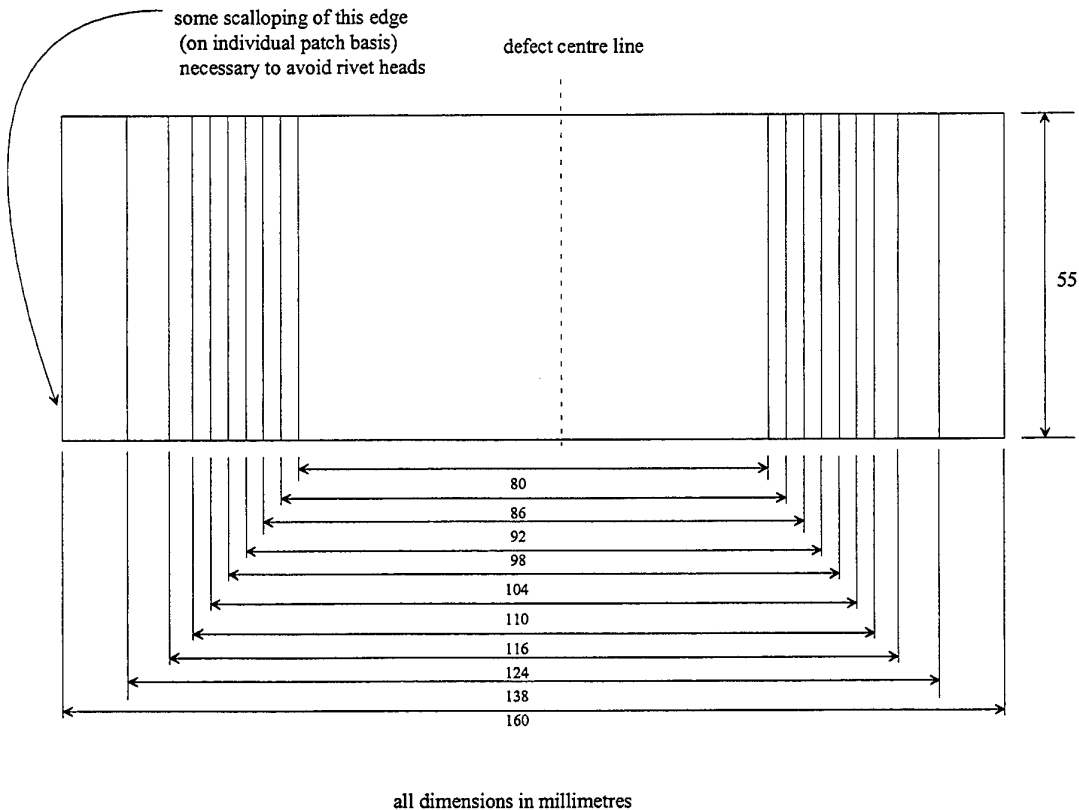
Figure 8. Drawing of the generic patch applied to the drain holes.

Five cracked lower wing-skin drain holes (P1,P2, S1, P5 and S2) were patched as shown in Figure 3. The drain holes were progressively patched between 23,875 SFH and 44,000 SFH (see Table 1) at scheduled downtimes for the test rig so as to minimise disruptions to the test. The locations of the drain hole patches were shown in Figure 3. The boron/epoxy patches stopped crack growth. A drawing of the generic patch applied to the drain holes is shown in Figure 8.

Details on the design and application of the drain hole patches are given in Reference 6.

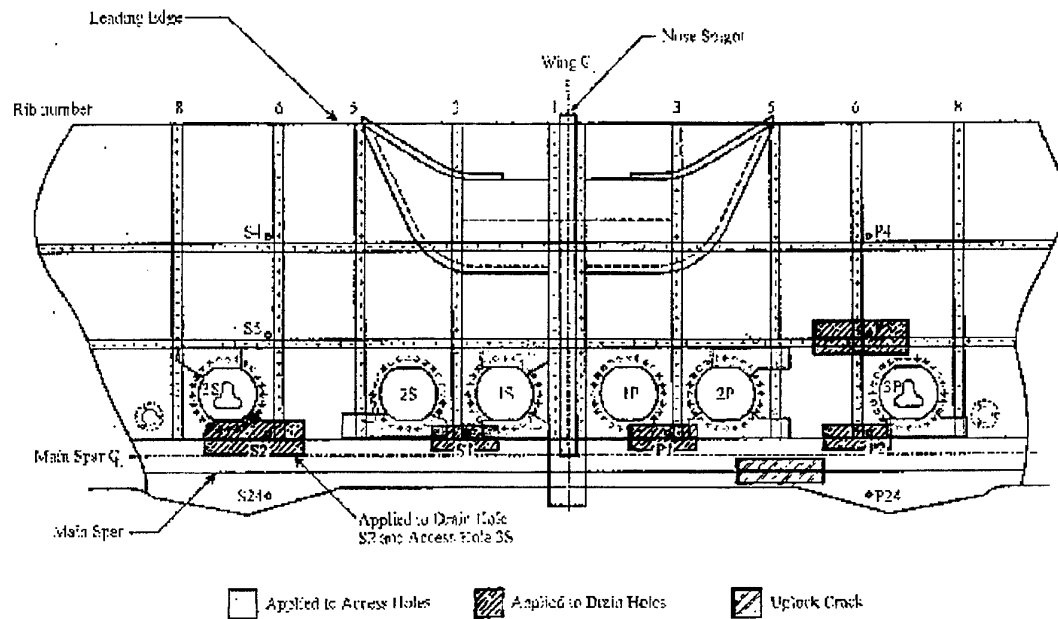
Figure 9. Drawing showing the locations and the nomenclature for the access hole repairs [2].

Seven patches to six cracked lower wing-skin access holes were applied progressively from about 37,000 SFH. The locations of the drain hole patches are shown in Figure 9. Inspection by eddy currents showed that the boron/epoxy patches were very successful in stopping crack growth.
